Urgent Safety Notice

Precautionary replacement of motors on older treatment tables

Re: GYM and GYM X treatment tables from FREI AG

From: FREI AG Aktive Reha-Systeme, Am Fischerrain 8, 79199 Kirchzarten, Germany

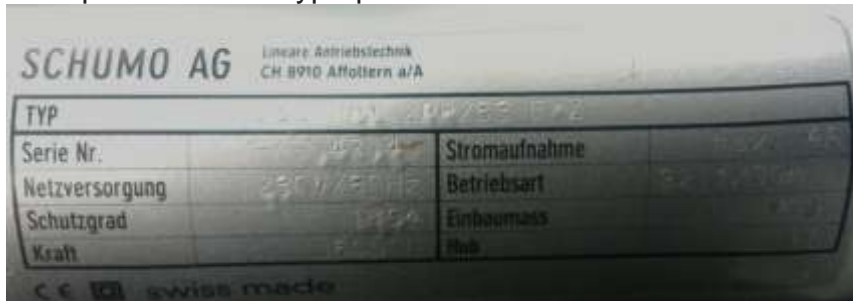
Example of a motor type plate:

Check the year of manufacture of all adjustment motors on your treatment tables. Motors older than 10 years should be replaced as a precaution. The age of the motor is indicated on the type plate of the motor or on the treatment table.

Without year of construction:
very old engine

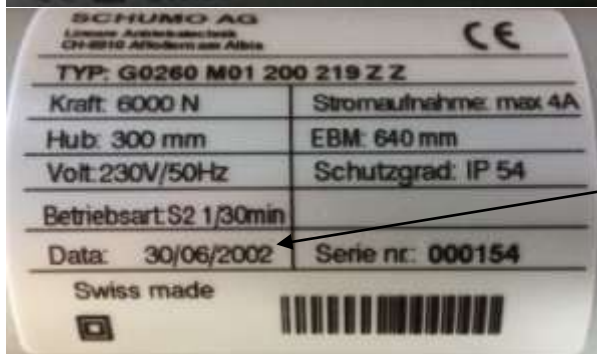
Year of construction 2002- today 16 years old
