## **Urgent Field Safety Notice**

### **StealthStation™ Cranial and Synergy™ Cranial**

#### **Depth Gauge Inaccuracy**

Medtronic reference: FA848

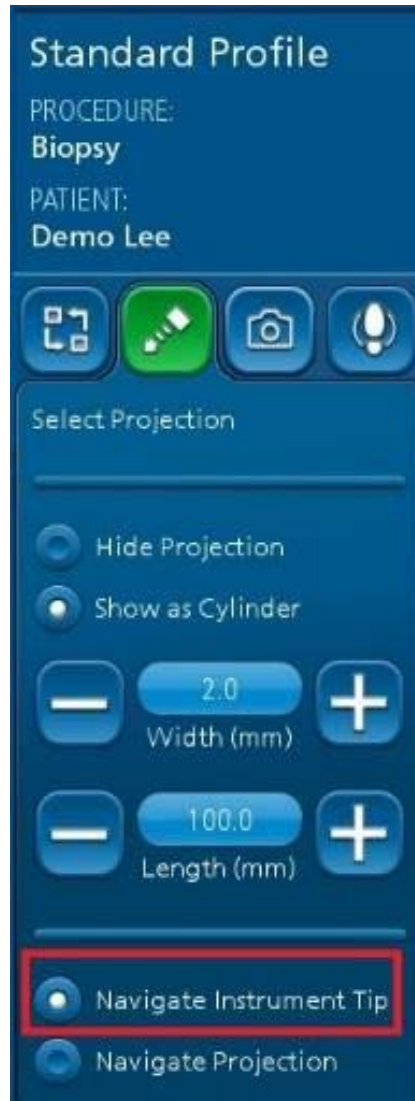
- Do not set a projection longer than the length of the surgical plan.
- Per the Cranial Software Pocket Guide, always use the Biopsy Needle Mechanical Depth Stop.
- Ensure *Navigate Instrument Tip* setting is selected prior to locking the trajectory and subsequently navigating the instrument (see image below).
