Urgent Field Safety Notice

Our Ref: 4215 FSCA

VITEK® 2 Identification (ID) / Antimicrobial Susceptibility Test (AST) Cards referenced in Appendix A.

FSCA 4215 : VITEK® 2 – Card Pouch Integrity

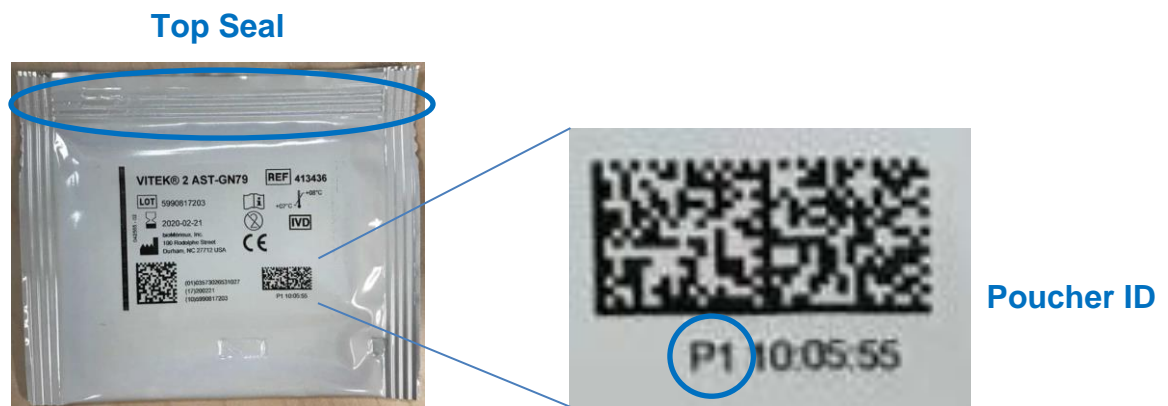
Figure 1: Top Seal and Pouch ID

A potential issue was identified related to the top seal of card pouches containing the VITEK® 2 test cards for the product lots specified in Appendix A. bioMérieux has determined that the integrity of some of the VITEK® 2 test card top seal may be compromised (see Figure 1). Based on our investigation, a compromised test card top seal can impact card reagents due to the entry of moisture.

bioMérieux investigation concluded that the pouch top seal of the card lots manufactured on a specific card poucher (Pouch 1) between 10Aug2018 and 29Aug2018 is potentially compromised. A small section of the top seal may be improperly sealed for the card lots indicated in Appendix A.

1. As VITEK® 2 ID/AST cards may be pouched on different pouching equipment in manufacturing, confirm the card was pouched on Pouch P1 and determine if a P1 indication is present (Figure 1). Cards that have other identifiers, such as P2, P3, etc. are not impacted.
2. Grasp the card pouch so the top seam is facing you.
3. Apply a modest pulling force to each side of the top edge of the pouch, at three (3) separate points as shown in the images below.
