March X, 2019  
Olympus reference: QIL 151-010

## URGENT FIELD SAFETY NOTICE

### HANDLING INSTRUCTIONS FOR THE OLYMPUS MAJ-209 SINGLE-USE SUCTION VALVE

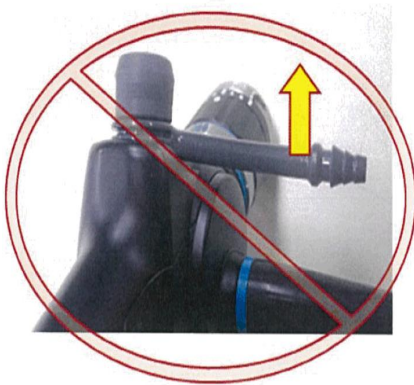
**I. Which movement of the MAJ-209 suction valve tube has to be avoided in order to prevent valve breakage?**

- An upward lifting of the suction valve's main body pipe away from the endoscopes has to be avoided.

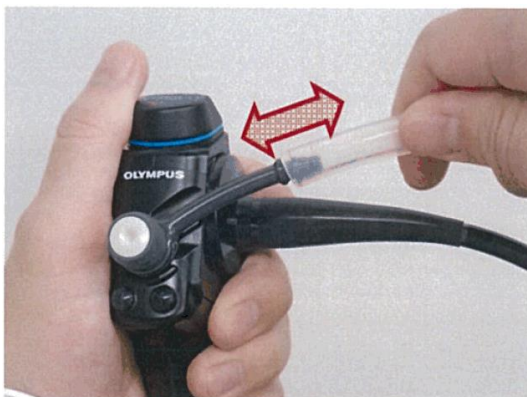
**1**

Attaching and detaching the suction tube only with pushing- /pulling-force in direction of the suction valve.

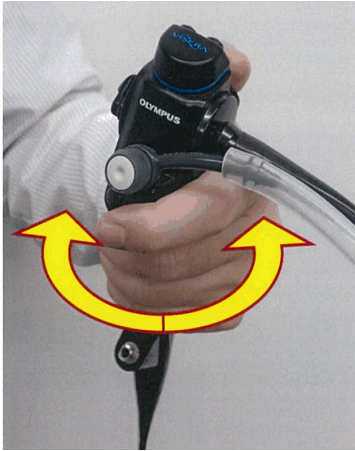
2

With attached suction tube: While using rotation movement **avoid pulling the attached tubing**. Assure to have **sufficient tube length** available in order to avoid pulling forces to the suction valve's main body pipe.

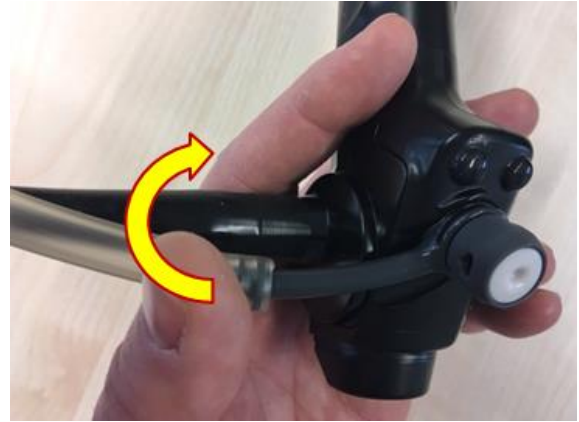
Disconnect the suction valve after the procedure with a clock-wise turn and slight pressure on the suction valve's main body pipe in direction of the scope (contrary movement to the one that would lead to breakage).

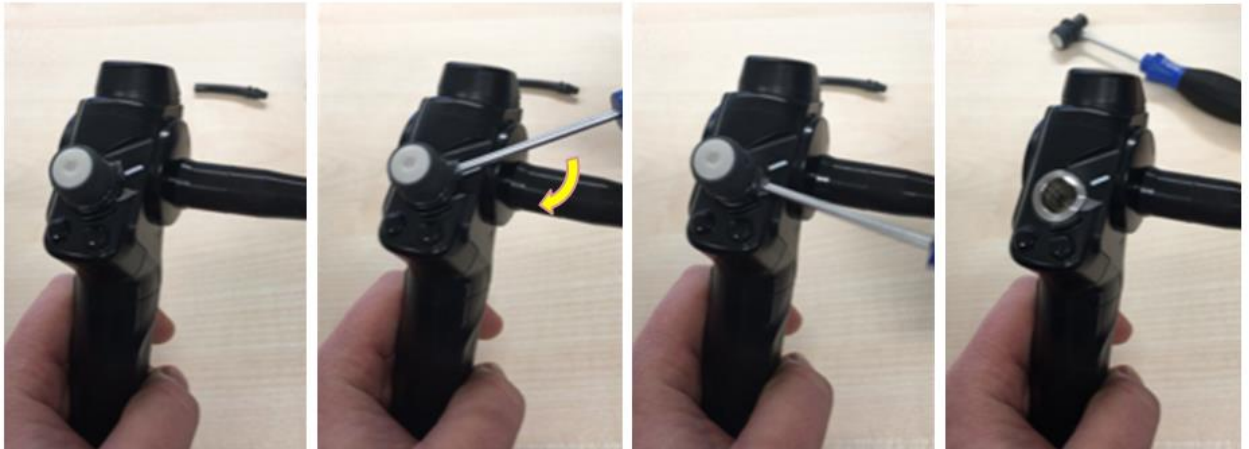
### III. How can the broken MAJ-209 valve be removed from the bronchoscope?

- In order to allow removal of the remaining suction body, for example a small screw-driver or scissor can be inserted into the ruptured tube opening of the suction valve. A clock-wise turn will then remove the broken valve from the bronchoscope/other endoscopes.
