## URGENT FIELD SAFETY NOTICE

GEHC Ref# 12283

RE: **Senographe Pristina with Serena – Potential slippage of the biopsy positioner when the gantry is rotated during a biopsy procedure.**

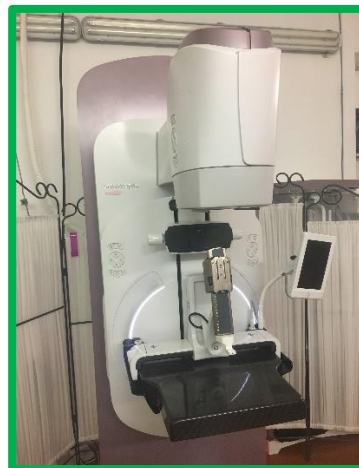
**Figure #1 – Acceptable Gantry Position for Biopsy Procedure:** Senographe Pristina gantry rotation angle is 0°. Vertical approach setup.

- You may continue to perform biopsy procedures when the Senographe Pristina gantry is **not** rotated in vertical or horizontal biopsy approaches. See Figure #1 and #2.
- **Do Not Use** your Pristina Serena system to perform biopsy procedures at **any** gantry rotation other than 0°. See Figure #3 & Figure #4.

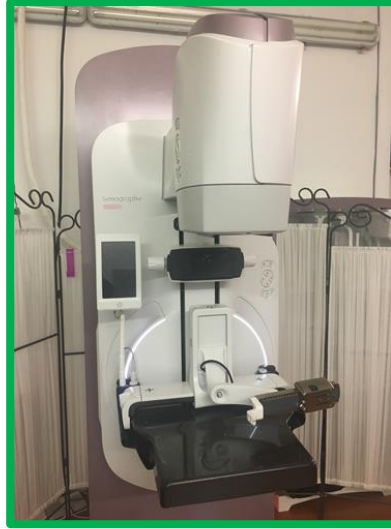
**Figure #2 – Acceptable Gantry Position for Biopsy Procedure:** Senographe Pristina gantry rotation angle is 0°. Horizontal approach setup.

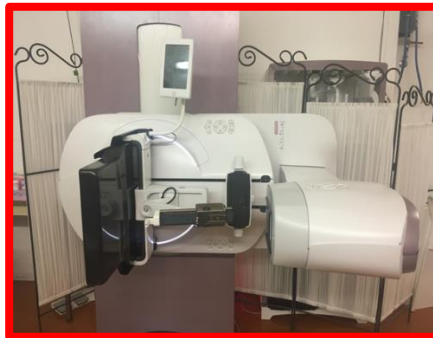
**Figure #3 – Do Not Use Gantry Rotation for Biopsy Procedure:** Senographe Pristina gantry rotated at 90° position.

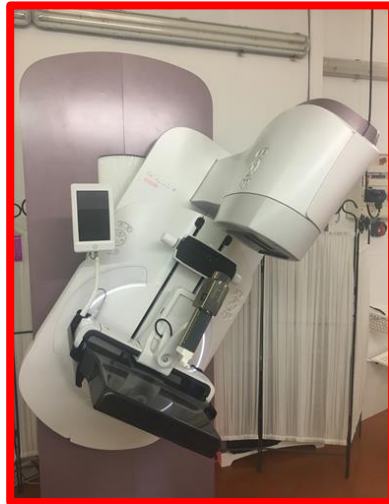
**Figure #4 – Do Not Use Gantry Rotation for Biopsy Procedure:** Senographe Pristina gantry at ANY rotation different from 0°.
