Batch recall of titanium tips

Name of the product concerned: TITANIUM TIP EASYTIP 2.2MM 30°

Article no.: VV800735A

Type of measure: Batch recall

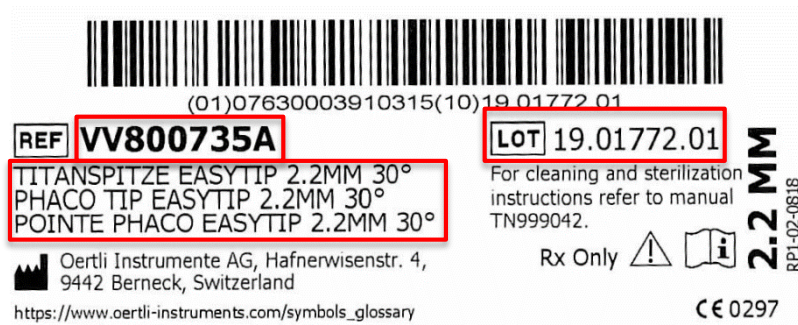
Article number, article designation and batch number (LOT) are shown on the label as follows:

1. Compare your inventory with the item name and number listed above and the batch numbers listed in the chart.

2. Immediately **stop using** the affected products listed in this letter and remove them from your inventory. Note: Any other batches that are not affected by this recall can still be used.
3. Please fill in the enclosed answer form and send it back to us, even if you have no stock affected by this recall action. Oertli requires your information for coordination purposes with the supervisory authority.
