Urgent Field Safety Notice
Needle guide bushings for stereotactic breast biopsy

Urgent Field Safety Notice (FSN)
Needle guide bushings for stereotactic breast biopsy
may fail

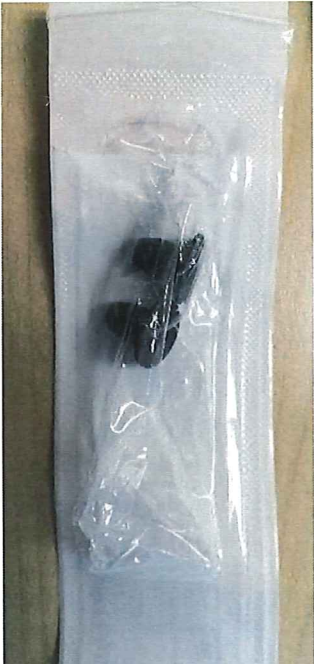
<p>Picture 1</p> </div> <div style="text-align: center;">

1. Information on Affected Devices*	
1	<p>1. Device Type(s)*</p> <p>Sterile needle guide bushings for one-time use. These bushings are delivered sterile in pairs, i.e. one package includes two (2) bushings, according to picture 1. When using the stereotactic breast biopsy device, these bushings are used to guide the biopsy needle through the needle holder according to picture 2.</p> <div style="display: flex; justify-content: space-around; align-items: center;"> <div style="text-align: center;">

2 Reason for Field Safety Corrective Action (FSCA)*	
2	1. Description of the product problem*
.	Some bushings have a material defect, which makes them brittle. The degree of this material defect varies. However, some of them, may break during normal usage in the field. This has happened and has consequently been reported.
2	2. Hazard giving rise to the FSCA*
.	When a bushing breaks, parts of it may fall on the breast, i.e. around the needle's entry into the breast. This may require the biopsy operator to clean the breast, remove the needle and replace the bushing. This could lead to extended surgery time and a potentially stressful situation for both patient and operator. No injuries have been reported due to this issue.
2	3. Probability of problem arising
.	N/A

3. Type of Action to mitigate the risk*			
3.	<p style="color: red; font-weight: bold;">1. Action To Be Taken by the User*</p> <p> <input type="checkbox"/> Identify Device <input type="checkbox"/> Quarantine Device <input type="checkbox"/> Return Device <input checked="" type="checkbox"/> Destroy Device </p> <p> <input type="checkbox"/> On-site device modification/inspection </p> <p> <input type="checkbox"/> Follow patient management recommendations </p> <p> <input type="checkbox"/> Take note of amendment/reinforcement of Instructions For Use (IFU) </p> <p> <input type="checkbox"/> Other <input type="checkbox"/> None </p> <p> If you have any of these bushings remaining, we strongly advise you, to stop using them. We will immediately and free of charge send you replacement bushings in stainless steel. For replacement please send an email to bushing@turonmedtech.com and you will get immediate respond with replacement instructions. </p> <p> Note that these stainless-steel bushings will be delivered nonsterile. A sterilization instruction will come with the bushings. </p>
