URGENT - Medical Device Correction

Pneumograph, Chest, NM, 3160

Device Labeling Does Not Include Statement Regarding Natural Rubber Latex Content

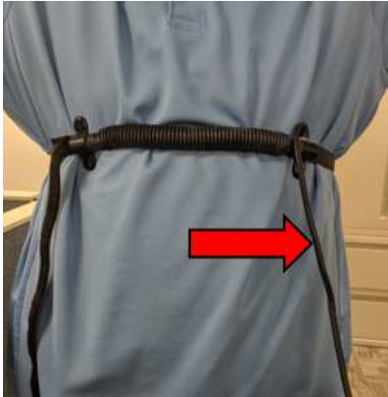
AFFECTED PRODUCTS	<table border="1"> <thead> <tr> <th>Part Number</th><th>Part Description</th></tr> </thead> <tbody> <tr> <td>94023</td><td>Pneumograph, chest, NM, 3160</td></tr> </tbody> </table> <p>All chest pneumographs currently in distribution are affected.</p>	Part Number	Part Description	94023	Pneumograph, chest, NM, 3160
Part Number	Part Description				
94023	Pneumograph, chest, NM, 3160				
PROBLEM DESCRIPTION	<p>The chest pneumograph contains 90-95% natural rubber latex in the tubing that extends from the bellows to the wireless oxygen saturation/pulse oximetry (SpO2) module or gating unit (refer to red arrow in the picture to the right). The chest pneumograph is not labeled as containing natural rubber latex.</p>

ACTION TO BE TAKEN BY CUSTOMER / USER	<p>Please review this communication with all members of your staff who utilize this product. Please retain a copy with the equipment Instructions for Use.</p> <p>The chest pneumograph can continue to be used for monitoring as directed by a physician.</p> <ol style="list-style-type: none">1. Identify all affected chest pneumographs in your facility using the guidelines provided in the HOW TO IDENTIFY AFFECTED PRODUCTS section above.<ul style="list-style-type: none">• <i>Please do not return any product to Philips.</i>2. Complete and sign the reply form provided on the last page of this letter.3. Send the completed and signed reply form to Philips via the contact information located on the form.4. Upon receipt of the reply form, Philips will send you one kit per chest pneumograph in your possession along with instructions for labeling each chest pneumograph.5. Upon receipt of the kit, follow the included instructions to label each chest pneumograph in your possession. The label to be added identifies the product as containing latex.

ACTIONS PLANNED BY PHILIPS	Upon receipt of the completed and signed reply form, Philips will provide one kit per chest pneumograph in each customer's possession for the purposes of labeling each affected chest pneumograph. This kit will be provided free of charge.
FURTHER INFORMATION AND SUPPORT	<p>If you need any further information or support concerning this problem, please contact your local Philips representative:</p> <p>0800 80 3000</p>

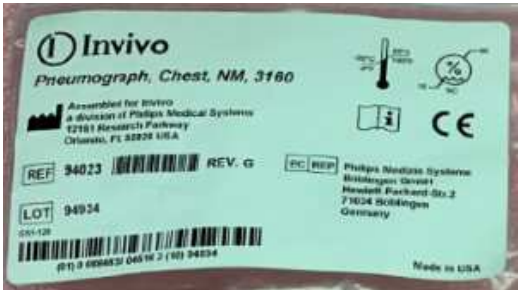
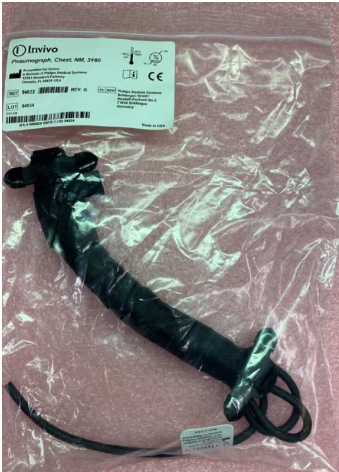
HAZARD INVOLVED	<p>Natural rubber latex is a known allergen that may impact the patient or user due to contact with the device against bare skin. The chest pneumograph is expected to be used over a gown or clothing but there is the possibility of the natural rubber latex tubing contacting the patient's bare arm/leg, patient's bare torso (if no clothing is present), or the user's hands/arms during patient preparation. Allergen related issues could range from minor (irritation or rash) to major (anaphylactic shock).</p>				
HOW TO IDENTIFY AFFECTED PRODUCTS	<p>The pictures to the right and below show the chest pneumograph part as packaged, as well as the label located on the outer packaging.</p> <div style="display: flex; justify-content: space-around;">
