URGENT FIELD SAFETY NOTICE

RECALL OF A SPECIFIC GYRUS ACMI SMART STAPES PISTON LOT NUMBER FROM THE FIELD

Description	Model Name	Article Number	LOT number
Gyrus ACMI Smart Prostheses	Smart Piston 0,4mm x 5,25mm	70142168 (article number on the packaging) EG70142168 (ordering article number)	PR898678

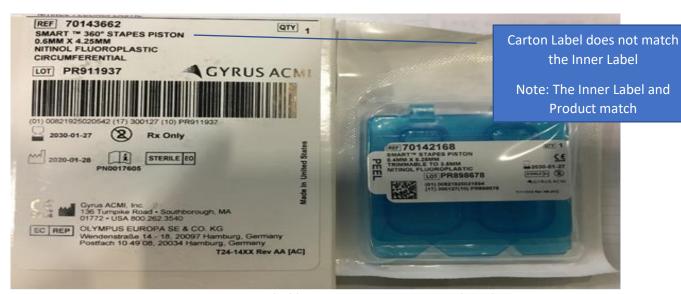
Due to an anomaly in packaging, a quantity of Stapes Piston were packaged with the outer carton label stating the contents were the 70143662 (EG70143662) Stapes Piston but the inside package contents was the 70142158 (EG70142158) Stapes Piston. (see picture 1) Olympus has received a non-injury complaint of a user receiving the mispackaged Stapes Piston. The insertion of an incorrect length Smart Piston may cause vertigo and loss in the inner ear function.

Picture 1: Carton label (left) and inner packaging label (right)

- 1. Immediately inspect your inventory for the affected Stapes Piston and identify the specified lot number.
- 2. Return your inventory of the above mentioned lot number to your local Olympus organization at XXXXXX to get a free of charge replacement/credit note in return. Indicate on the enclosed Reply Form that you have received and understood this Field Safety Notice as well as the quantities per LOT number you are going to return to Olympus. Olympus will provide a free of charge replacement or a credit note to your facility for any returned affected products.
