***Urgent Field Safety Notice for:
Dako Autostainer Instruments (AS480; AS100; S3800; S3400):***

Update of Autostainer Link Basic User Guide to reduce risks of staining issues due to leakage

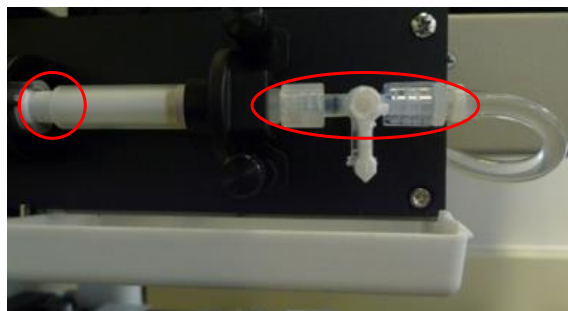
Visually inspect the syringe tray, syringe and stopcock, areas highlighted in red, for signs of unexpected leakage (salt residues and/or liquid).

If there are signs of unexpected leakage (salt residues and/or liquid), contact your local Technical Service representative immediately as this might indicate a leakage in the system.

Visually Inspect the syringe tray, syringe and stopcock for salt residues and/or liquid, see picture below. If there are signs of unexpected salt residues and/or liquid, contact your local Agilent Technical Service representative as this might indicate a leakage in the system.

Wipe the syringe tray with a sponge or a soft cloth soaked with DI water or mild detergent to remove dust and potential salt crystals. Do not use abrasive cleansers.”

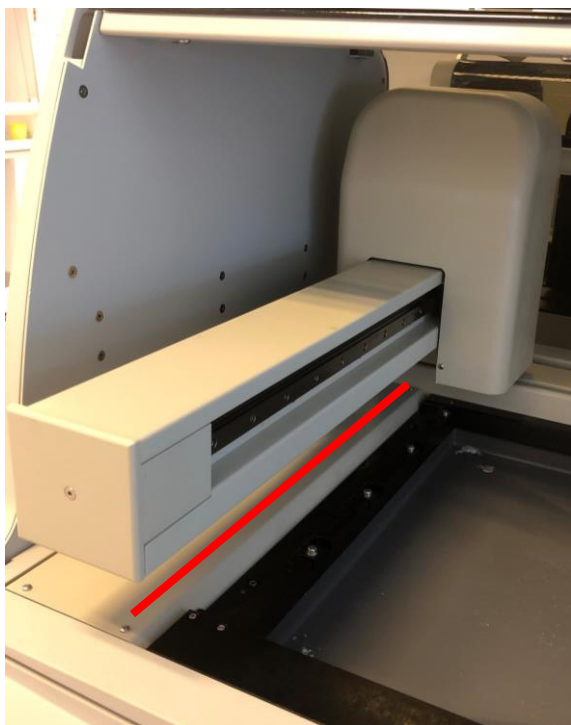
Visually inspect the left plate, area highlighted in red, for signs of unexpected leakage (salt residues and/or liquid). This might indicate leakage from the robotic arm.

Visually Inspect the left plate, and the area around the wash station for salt residues and/or liquid, see pictures below. If there are signs of unexpected salt residues and/or liquid, contact your local Agilent Technical Service representative as this might indicate a leakage in the liquid system. If leakage is observed, the slides from the run just completed must be closely reviewed for staining abnormalities.”

WARNING Leakage from the robotic arm or z-head may impact staining quality. Do not use the instrument if there are signs of unexpected leakage (salt residues and/or liquid), or if you observe leakage.

Immediately contact your local Technical Service representative.

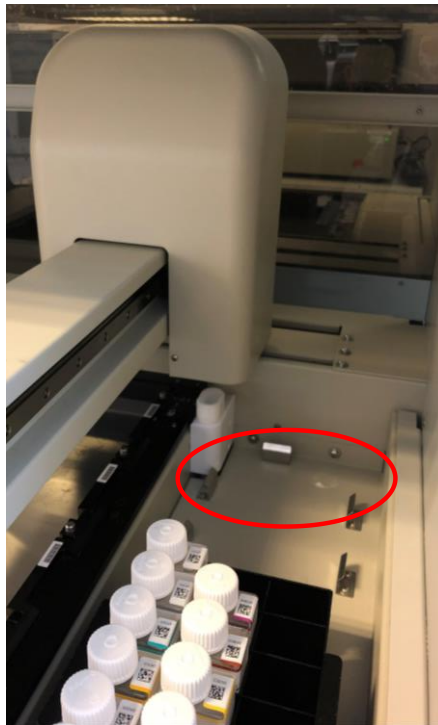
Visually inspect the area around the wash station, area highlighted in red, for signs of unexpected leakage (salt residues and/or liquid). This might indicate leakage from the z-head or too high pump pressure.
