Urgent FIELD SAFETY NOTICE

Device: Terumo® Extracorporeal blood circuits, Tubing sets and Ancillary devices Reference: FSN 2102 -- 2021-05

Annex – instructions for seal inspection

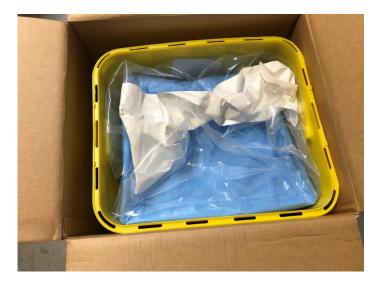
Image 1 – Pack when opened

- 1. On receipt of the packs please carefully open the outer packaging.
- 2. Remove the cardboard interleave and any documentation.
- 3. Once the cardboard interleave has been removed there will be a tubing set sealed within a gas bag placed within a yellow bin as shown in image 1 below.

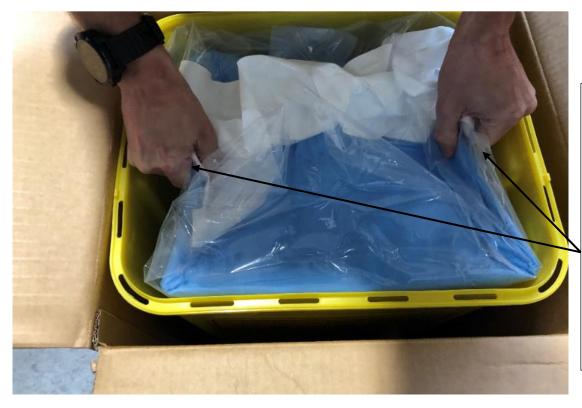
Image 2 – How to grip packs when removing

4. Remove the pack carefully by grabbing the plastic insert within the Primary packaging. Place one hand either side and pull by gripping both the product (within the plastic insert) and the packaging together. It is critical that you do not remove the pack by pulling only on the packaging. Image 2 shows how the pack is to be removed.

Remove the pack by placing one hand either side and pull by gripping both the product (within the plastic insert) and the packaging together as shown in image 2.

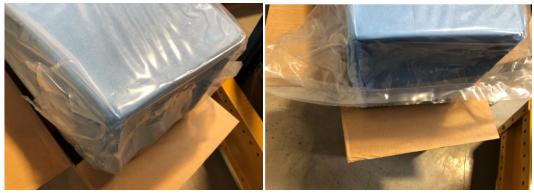
Image 3 – Pack as seen when removed from yellow bin

5. Once the packs have been removed place on their side and inspect packaging. The seal on the bottom of the pack should be intact as shown in image 3 below. If the pack has been removed by pulling on the gas bag without holding the plastic insert it is possible that the seal has come open (as shown in image 4). In this case the failure of the seal will be a wide opening of 10 - 15 cm.

Inspection – Inspect the bottom seal on removal: it should be sealed.

In the case that the seal is open the pack is to be discarded. An example of an open seal is shown in image 4 below.
