URGENT Field Safety Notice

M5071A (adult) and M5072A (infant/child) pads for use with HS1/OnSite/Home AEDs may experience gel separation and reduction of gel surface area

21-FEB-2022

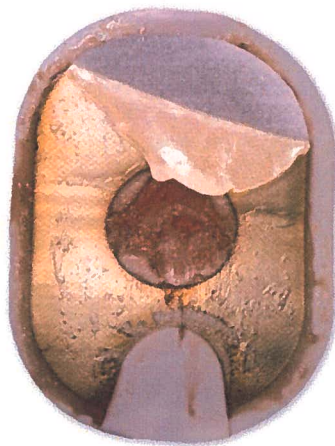
Separated, folded gel may also have a discolored and/or melted appearance. While the gel may also have a discolored and/or melted appearance, the appearance does not have any impact on the delivery of therapy; however, there may be a delay in therapy if the user hesitates to apply the pad due to its appearance, and the AED may deliver less effective or ineffective therapy to the patient due to the reduced contact area with the skin. See example picture in **Figure 2**.

Figure 2: Separated, folded gel may also have a discolored and/or melted appearance.

Action:
Apply pads to the patient.
Do not hesitate.

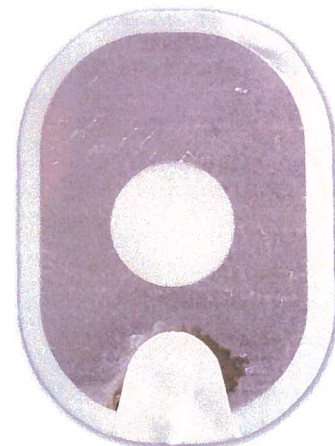
It is also possible that the gel could separate almost completely from the foam/tin backing when peeled, (see **Figure 3**.) Due to a small amount of gel surface contact area with the skin, electrical arcing could occur when a shock is delivered leading to burns to the patient's skin, or the AED could be unable to deliver any shock through the pads. A delay in therapy will result while the user installs a replacement pads cartridge (if available) or performs CPR while waiting for Emergency Medical Services Personnel to arrive. For comparison, **Figure 4** shows a normal pad. No matter the state of the pad, follow the voice prompts because the AED will step you through the necessary actions.

Figure 3: Gel almost completely separated from backing.

Action:
Replace pads cartridge if a spare is available. If no spare is available, perform CPR until help arrives.

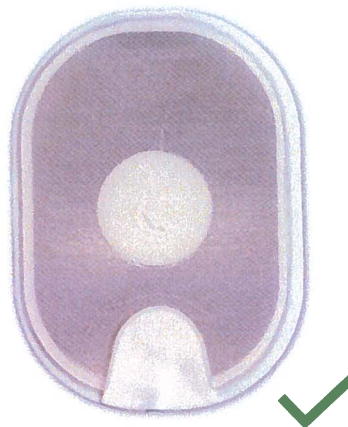
Figure 4: Normal pad.

Action:
Apply pads to the patient according to the Instructions for Use/Owner's Manual.
