UPDATE TO URGENT FIELD SAFETY NOTICE

MiniMed™ 600 and 700 series insulin pump Battery Cap

Notification

Medtronic Reference: FA1249

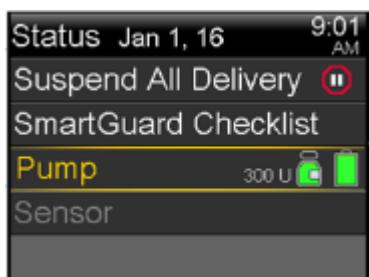
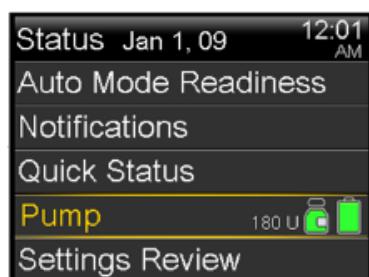
3. On the Status screen select **Pump**

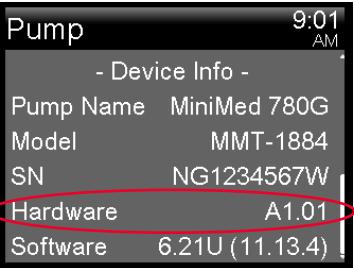
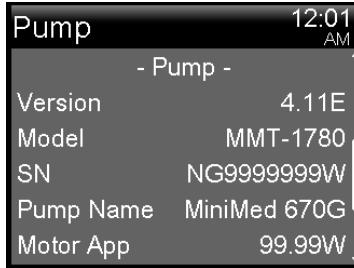
Pump 9:01 AM
- Device Info -
Pump Name MiniMed 780G
Model MMT-1884
SN NG1234567W
Hardware A1.01
Software 6.21U (11.13.4)

Pump 12:01 AM
- Pump -
Version 4.11E
Model MMT-1780
SN NG9999999W
Pump Name MiniMed 670G
Motor App 99.99W

Previous Pump Case examples with Hardware beginning with A1 or Hardware section is not shown

4. On the Pump screen, scroll down to check the **Hardware** version. If you have a new pump case, the **Hardware** version will begin with **A2**. If you have a previous case pump, the **Hardware** version either will not appear on the screen or shows **A1**.

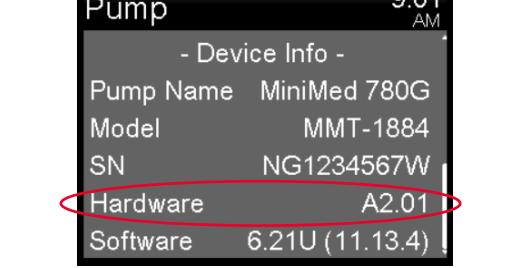
Pump 9:01 AM
- Device Info -
Pump Name MiniMed 780G
Model MMT-1884
SN NG1234567W
Hardware A2.01
Software 6.21U (11.13.4)

New Pump Case example with Hardware beginning with A2

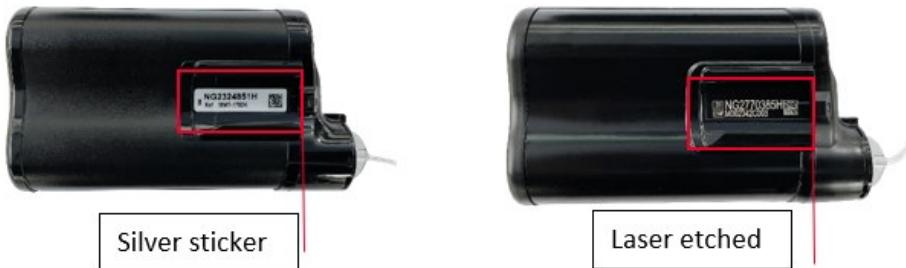
5. Another way to identify the new pump case is to look at the serial number on the outside of the pump. The serial number is located on the back of the pump underneath the belt clip. The serial number on the new pump case is laser etched onto the back of the pump whereas the serial number is on a silver sticker on the previous case pump.

Previous pump case (left) and new pump case (right)

Pumps with **Hardware** version beginning with **A2** or having a **laser etched** serial number are not affected, these pumps must not use battery cap model number ACC-1529.

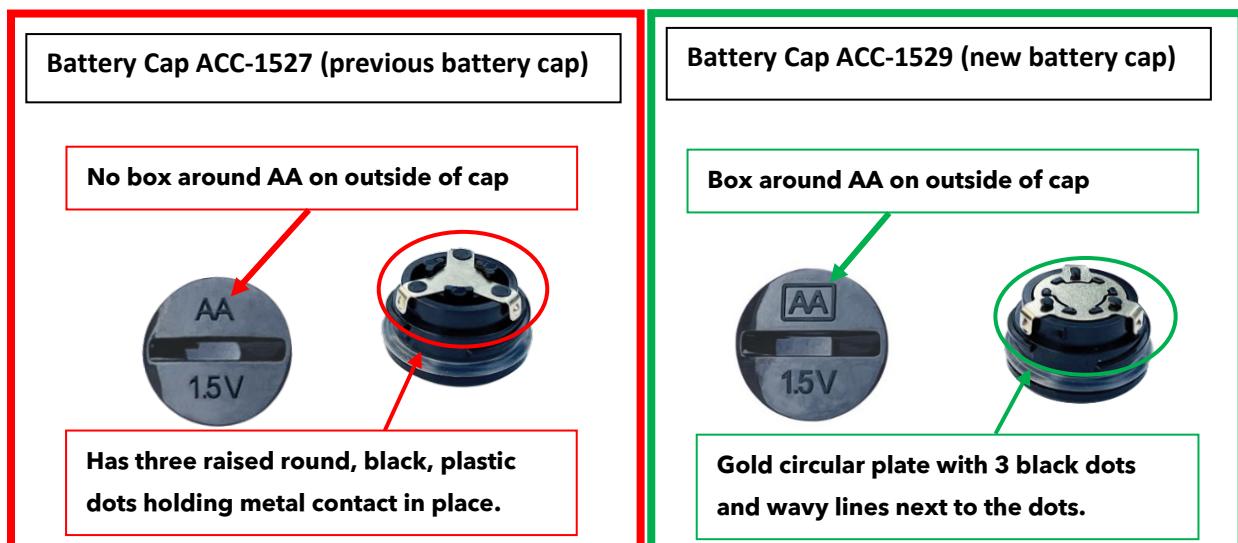
1. Gather your **previous case** insulin pump and **all** battery caps in your possession.
 - a. Only replace the battery cap on your **previous case pump**. If you have a **new case pump, do not replace the cap on it.**
2. Before you begin, make sure you have a new battery available; do not remove the battery cap unless you have a new battery available.
3. Look at the bottom and top of each battery cap and identify which battery cap(s) is the new cap (model number ACC-1529) for your **previous case pump** and which is the previous battery cap(s) (model number ACC-1527) using the pictures below:

4. Discard all previous battery caps, model number ACC-1527 for the previous case pump. There is no need to return anything to Medtronic.
5. Install the new battery cap (model number ACC-1529) onto your **previous case pump**.
