URGENT - FIELD SAFETY CORRECTIVE NOTICE

**GETINGE ED-FLOW, Automated Endoscope Reprocessor (AER)
Field Action CAPA 657027**

Date:	25-Oct-2022
Product Issue:	ED-FLOW Dosing issue, CAPA 657027
Affected Product:	Getinge ED-FLOW AER and ED-FLOW SD AER
UDI DI	No UDI – Product not sold in USA and is not an MDR product
SRN	N/A
Resolution:	<i>Getinge propose to rework the devices and remove mechanical interferences causing inconvenience and to make sure that all devices present in the market are working effectively and safely.</i>
Affected Serial Nos.:	All ED-FLOW AER-models manufactured since start 2010 until 2022-08-24.
Field Correction Notice:	<i>GD11651 Instruction for Field Action ED-Flow</i>
Pages:	6

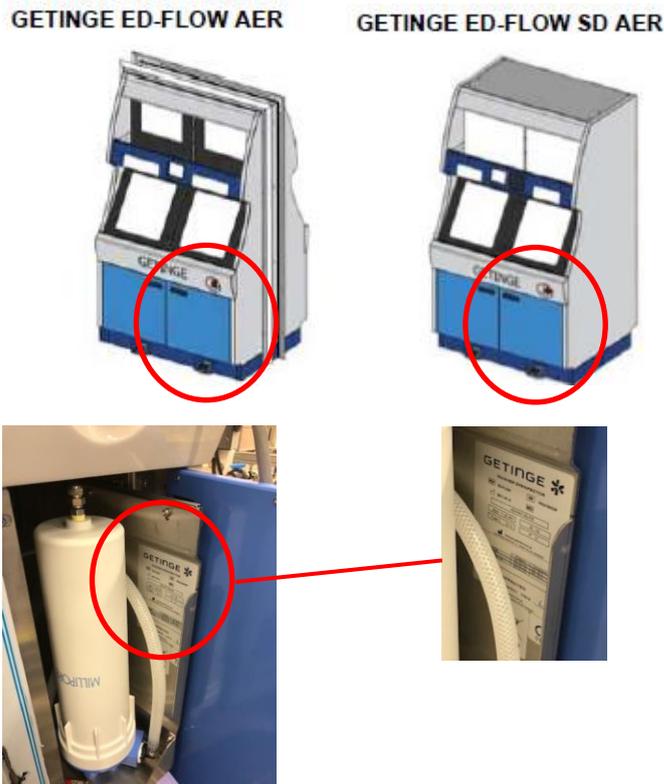
1. Check the serial number of the ED-FLOW AER. The serial number shall correspond with the serial number on the customer response form (Appendix 1).
The serial number can be found on the marking label, located on the inside of the right Panel door, see below.
