## **Urgent Field Safety Notice**

### **StealthStation™ S7 Cranial Software v3.1.4 Biopsy Depth Gauge Inaccuracy & Incorrect Distance to Target Text**

**Medtronic Reference: FA1324**

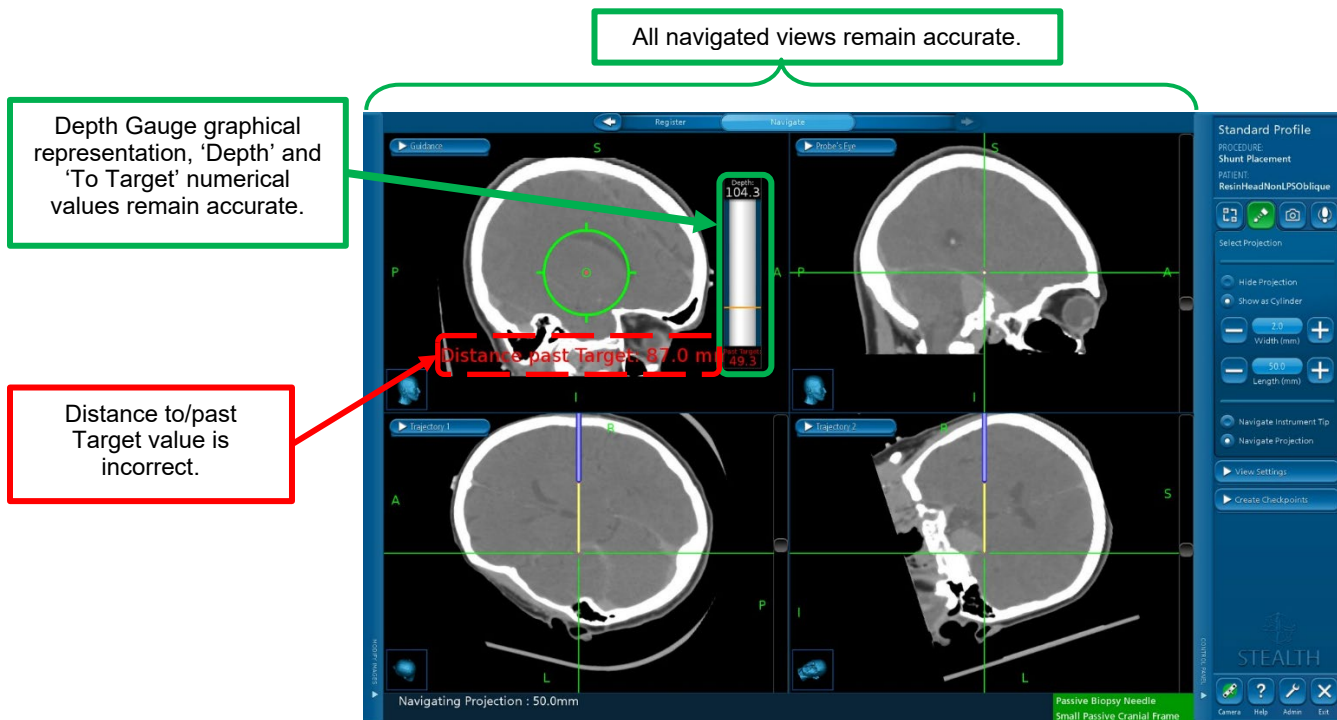
Medtronic identified an anomaly during our own internal testing that impacts Tumor Resection, Shunt Placement, (Refer to Figure 1) and Nexframe™ DBS procedures (Refer to Figure 2) with the Distance to/past Target text. This anomaly does not impact Cranial Biopsy procedures. When certain settings are used, the software can enter a state where the Distance to/past Target text is no longer synchronized with the rest of the navigational information on the screen and displays an inaccurate numerical value. All other information on the screen, including the Depth Gauge Graphic (Shunt Placement, Tumor Resection), remains accurate. The steps required to encounter this anomaly are as follows:

- Non-Axial exams (sagittal, coronal) and a small subset of non-standard Axial exams are used
- A surgical plan has been created and must be utilized.
- The Target Guidance option must be selected within the guidance view options.
- A tip projection must be utilized.
- The 'Navigate Projection' must be enabled.

Figure 1 Distance to/past Target Text Inaccuracy seen in Navigate Task of Shunt Placement and Tumor Resection

Medtronic recommends that users do not utilize the Distance to/past Target value (outlined in Red in Figure 1) in Tumor Resection, Shunt Placement, or Nexframe™ DBS procedures due to the potential for the presence of this software anomaly. All other navigation information is unaffected and can be utilized to complete the desired procedure. Per the IFU: “Warning: Frequently confirm navigation accuracy and system responsiveness during live navigation. Use the navigation instrument to touch several bony anatomical landmarks and confirm that the locations identified on the images match the locations touched on the patient. If accuracy degrades, re-register the patient.” and “If system navigation seems inaccurate and steps to restore accuracy are unsuccessful, abort use of the system.”

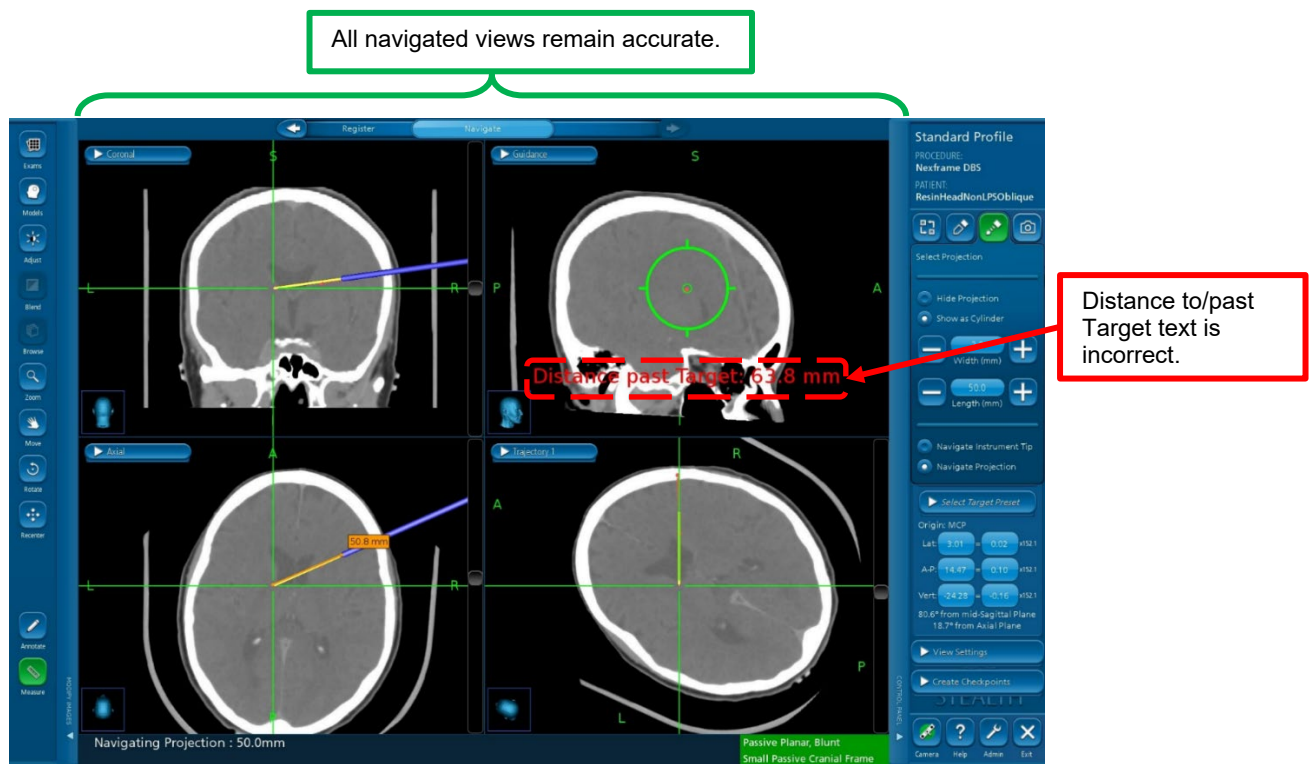
Figure 2 Distance to/past Target Text Inaccuracy seen in Navigate Task of NexFrame™ DBS

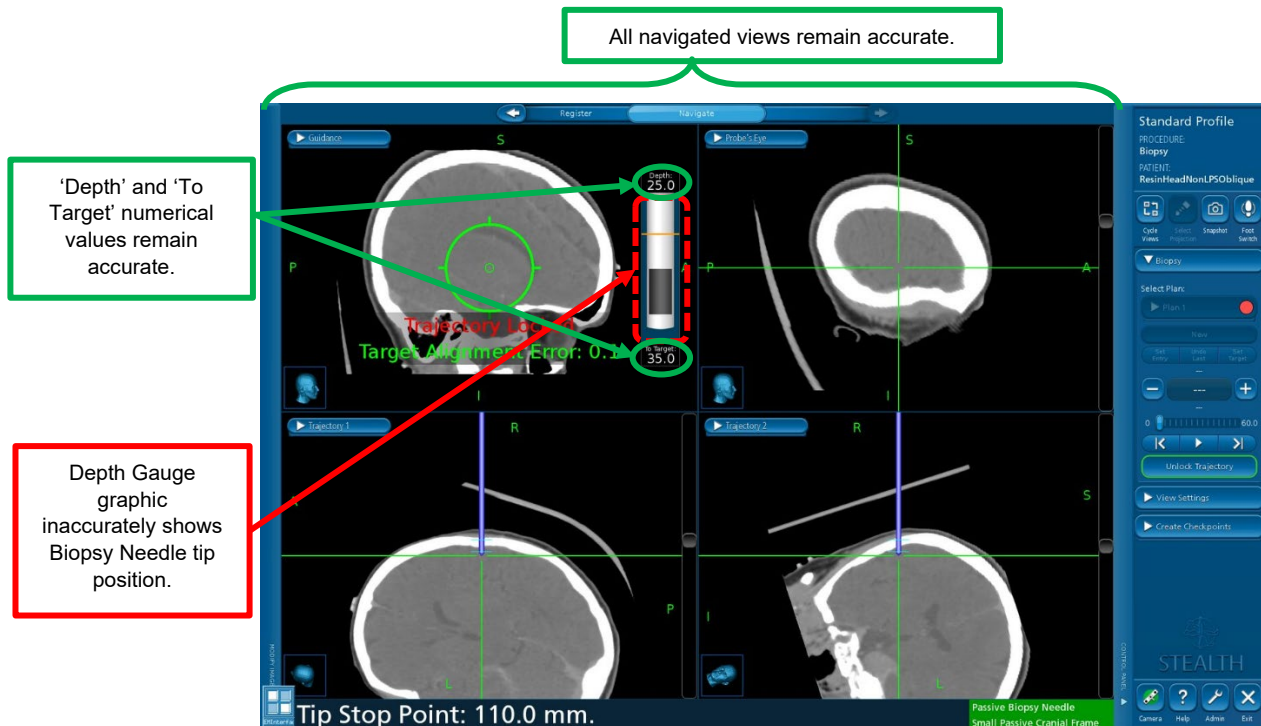
Medtronic has received three complaints reporting that during navigation in a Cranial Biopsy Procedure, the user encountered an anomaly with the Biopsy Depth Gauge graphical display in the software. Investigation of the complaints showed that when certain scan types are loaded and utilized, the software can enter a state where the Biopsy Depth Gauge graphic is no longer synchronized with the rest of the navigational information on the screen and displays an inaccurate position of the biopsy needle. This issue occurs with non-Axial exams (sagittal, coronal) and a small subset of non-standard Axial exams. All other information on the screen remains accurate.

Figure 3 Biopsy Depth Gauge Graphic Inaccuracy seen in Navigate Task

Medtronic recommends that users do not utilize the Biopsy Depth Gauge Graphic in Biopsy procedures due to the potential for the presence of this software anomaly. All other navigation information is unaffected and can be utilized to complete the desired procedure.

In accordance with the IFU: Frequently confirm navigation accuracy and system responsiveness during live navigation. Use the navigation instrument to touch several bony anatomical landmarks and confirm that the locations identified on the images match the locations touched on the patient. If accuracy degrades, re-register the patient. Always use the Biopsy Needle Mechanical Depth Stop. If system navigation seems inaccurate and steps to restore accuracy are unsuccessful, abort use of the system.
