**URGENT Field Safety Notice**

**INTELLIVUE MX40 PATIENT MONITOR**

**Reference:** CR # 2023-CC-HPM-014, Intellivue MX40 Patient Monitors

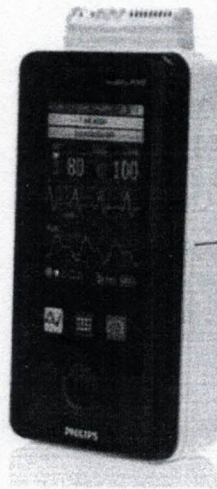
**Figure 1 – MX40 device**

When the MX40 is in Standby mode for an extended period without patient surveillance no monitoring or alarming is available because alarms, as designed, cannot be triggered when the MX40 is in standby mode.

2) if Infinite duration is used for Standby mode, the device will not resume monitoring until Standby is manually ended by the user or a "Tele Battery Low" INOP condition occurs. While the MX40 device is in Standby, physiological monitoring and alarming is stopped.

Therefore, there may be a hazardous situation present if a user places an MX40 in Standby longer than intended for completion of a patient procedure or test if the device is not taken out of Standby.

Please refer to the instructions in the IFU before using standby mode, see Sections: *Standby Behavior*, *Unit Configurable Settings* and *Global Settings*.

- To resume monitoring from Standby mode, Press the blue Main Screen Button or disconnect/reconnect the MX40 patient cable.

- If the MX40 is placed in a timed Standby mode duration (i.e., not Infinite), a Standby mode timer is displayed on the MX40 screen. If in infinite Standby mode, the *Standby* message is always displayed until the device sleeps. **Remember, when the device has been placed in Standby mode without the user choosing a time for when monitoring will resume (i.e., after 10, 20, 30 minutes or 1, 2, 3, or 4 hours), the device will remain in Standby mode until the user manually resumes monitoring thereby ending Standby mode.**
