URGENT FIELD SAFETY NOTICE – PRODUCT RECALL

BiMobile Dual Mobility System

BiMobile Dual Mobility System, Liner

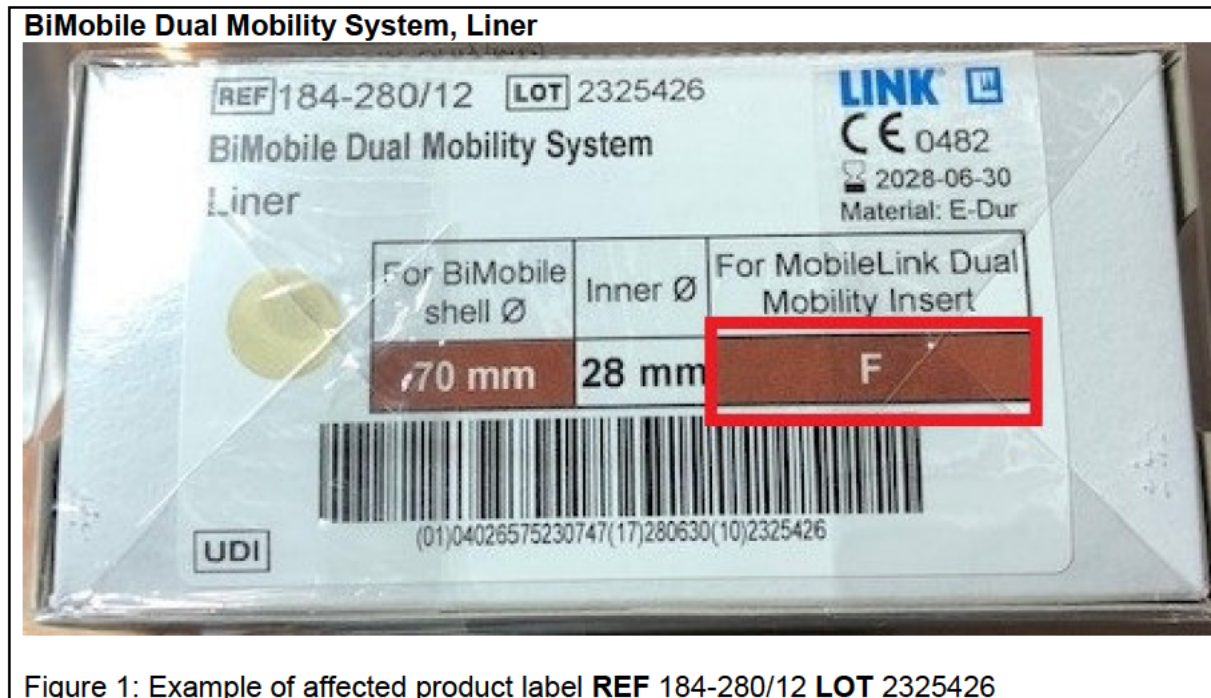
Figure 1: Example of affected product label **REF** 184-280/12 **LOT** 2325426

On the affected labels of the BiMobile Liner there is an incorrect letter “F” referring to the compatible size of the MobileLink Dual Mobility Insert.
The label should instead provide information for the compatibility to size “G”.
The brown color coding on the main label and the inner patient label have correct information size “G”.
This information is only relevant for the combination of MobileLink Dual Mobility insert with BiMobile Dual Mobility System Liner.

There is a risk because the label does not show the correct letter “G” referencing to the compatibility of the components. This may lead to confusion during surgery and a prolonged or modified surgery.
A MobileLink Dual Mobility insert size “F” could not be combined with the affected liners with article REF 184-280/12 and REF 184-260/12, as these were too large.

- ☒ Identify Device
- ☒ Quarantine Device
- ☒ Return Device
- ☐ Destroy Device
- ☐ On-site device modification / inspection
- ☐ Follow patient management recommendations
- ☐ Take note of amendment / reinforcement of Instructions For Use (IFU)
- ☐ Other
- ☐ None
 - Should you have any of the affected product in your inventory, please send the products back to Waldemar Link GmbH & Co. KG.
 - Should you have any question on acquiring alternative components for forthcoming surgeries, please contact your local sales representative or customer service for Link products.
 - Please return the reply form to us in any event until the **31.01.2024** as documentation of the recall. This applies even if you have none of the listed products in stock or if these products do not exhibit the defect in question.

- ☒ Product Removal
- ☐ On-site device modification / inspection
- ☐ Software upgrade
- ☐ IFU or labelling change
- ☐ Other
- ☐ None
